## Technical Service Handbook

Model description: **Phaeton 4M4-sea 230\_TDI6at**

### Technical product information

Electrics: Adaptive Cruise Control (ACC) doesn't work, warning light on

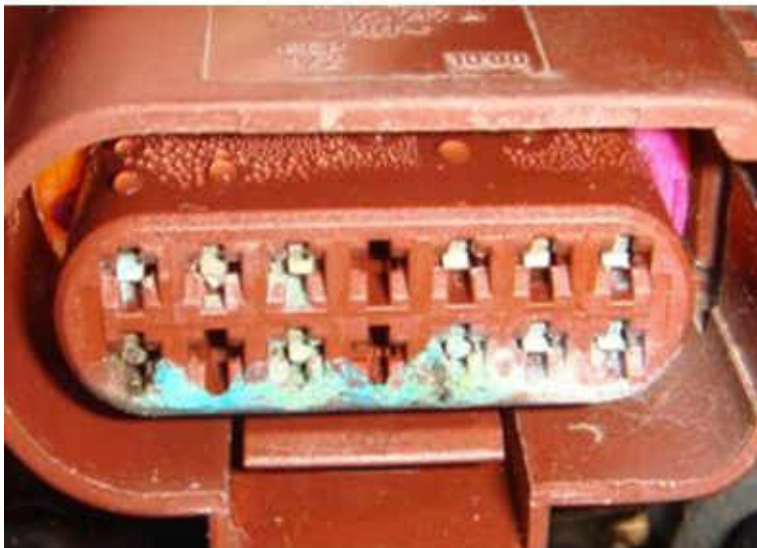
Electrics: Adaptive Cruise Control (ACC) doesn't work, warning light on

**Illustration 1:** Water ingress/contacts corroded on the connection (brown) of the brake servo control unit

Check the connectors on the brake servo control unit and on the brake servo for humidity and water ingress.

- Corroded cables must be replaced.
  - Fit the wiring loom **part number 3D1 970 221 N**.

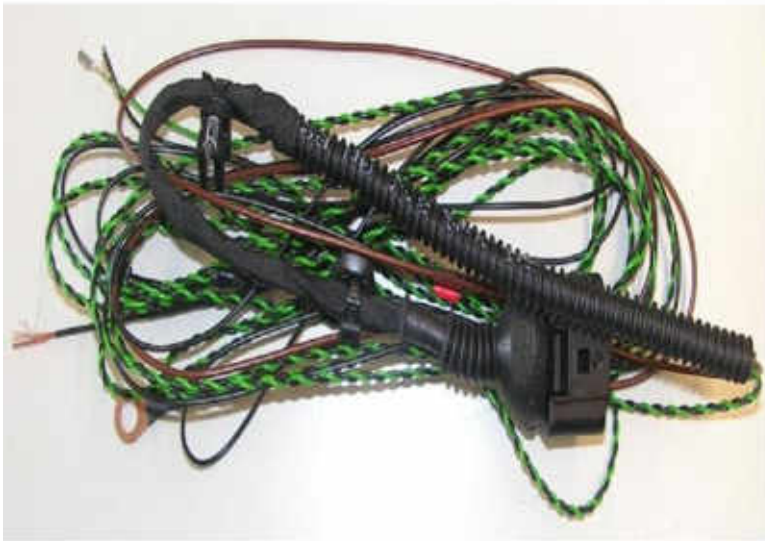
**Illustration 3:** Green/black cables twisted with earth connection

- Green/black cables twisted with earth connection(illustration 3). **These cables are normally not needed as replacement parts.**
- Adapter cable between brake servo control unit and brake servo (illustration 4)
- Fit also over the E-box in the plenum chamber the cover with **part number 3D0 907 299** (illustration 5).

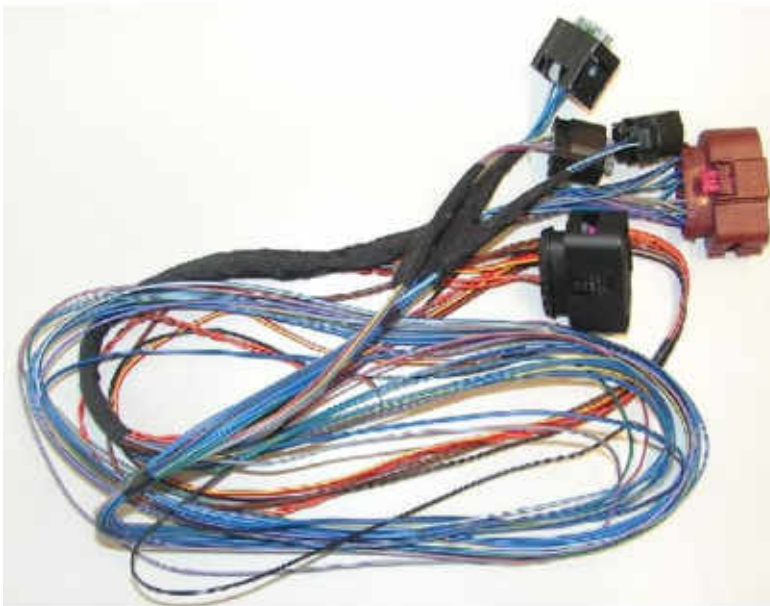
**Illustration 4:** Adapter wiring loom between brake servo control unit and brake servo

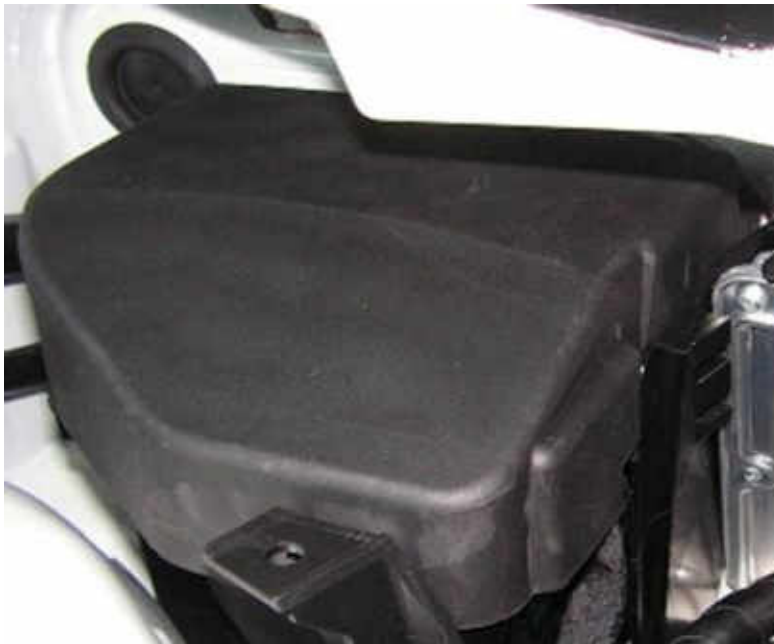
**Illustration 5:** cover over E-box in plenum chamber

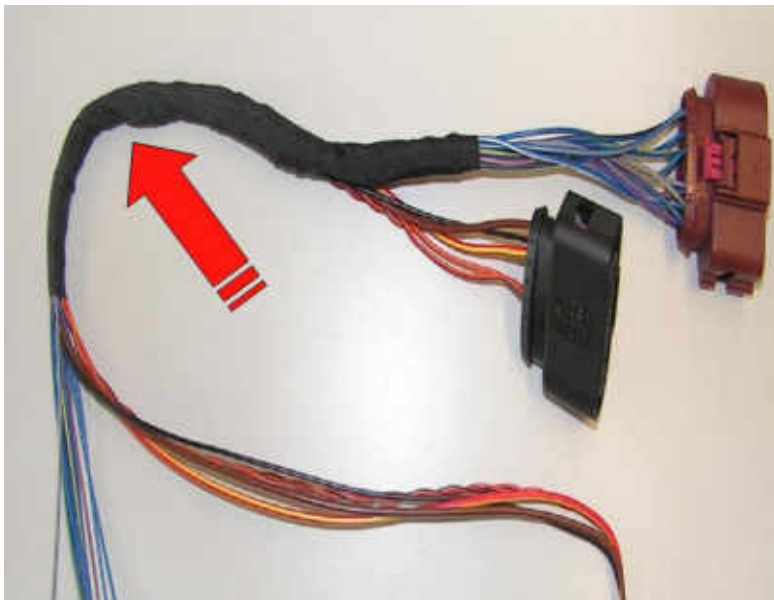
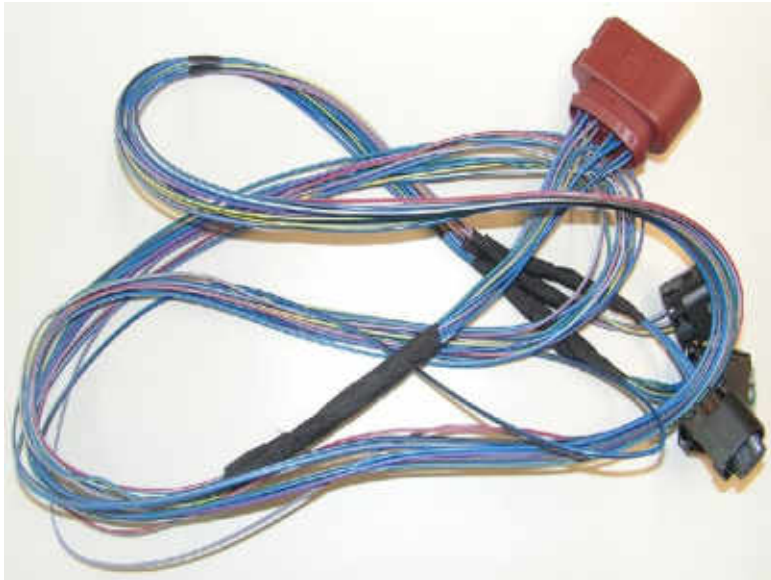
**Illustration 6:** Remove the wrapping tape

**Illustration 7:** Remove the wrapping tape

- Remove the wrapping tape on the adapter wiring loom (illustration 6, red arrow)  
Illustration 7 shows the wiring loom without black wrapping tape.

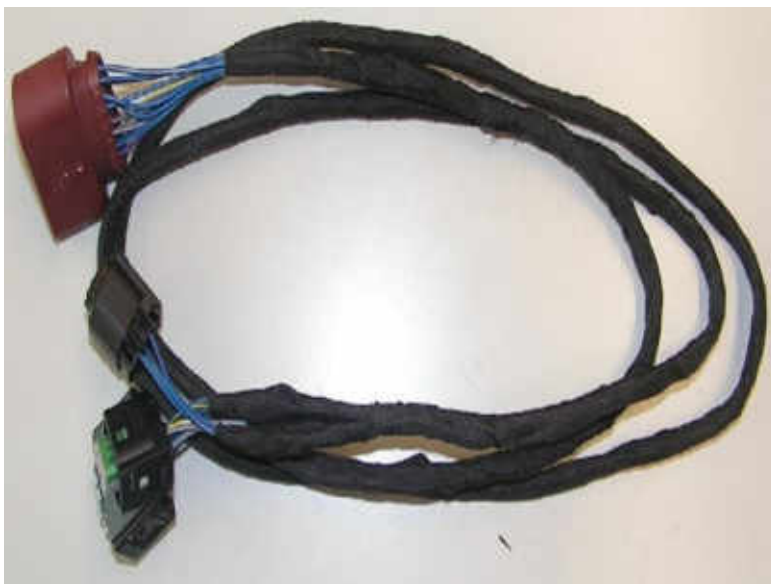
**Illustration 8:** Protection of adapter cable with tape

- Protect the adapter wiring loom (brown connector) and the 3 connectors to the brake servo with tape (illustration 8).

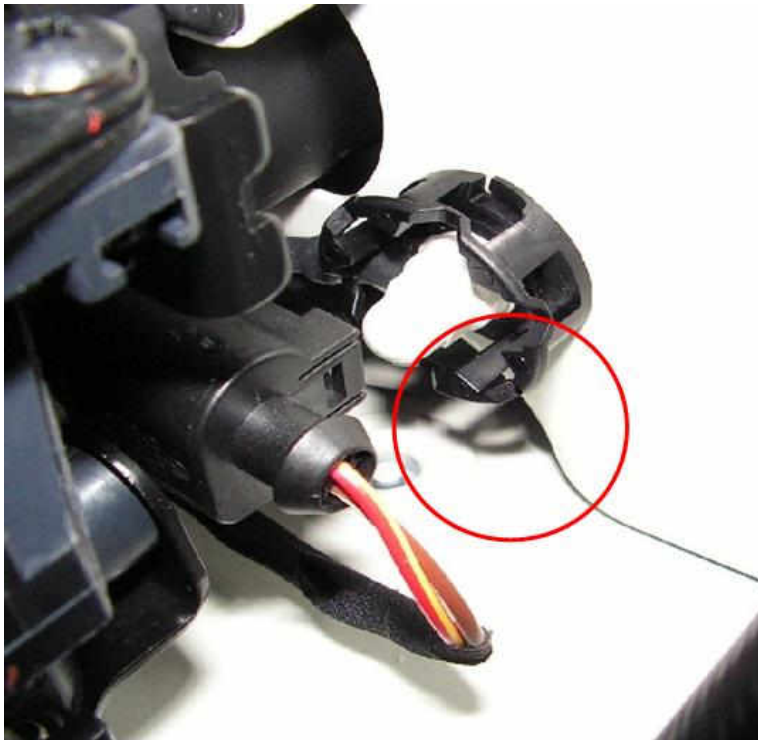
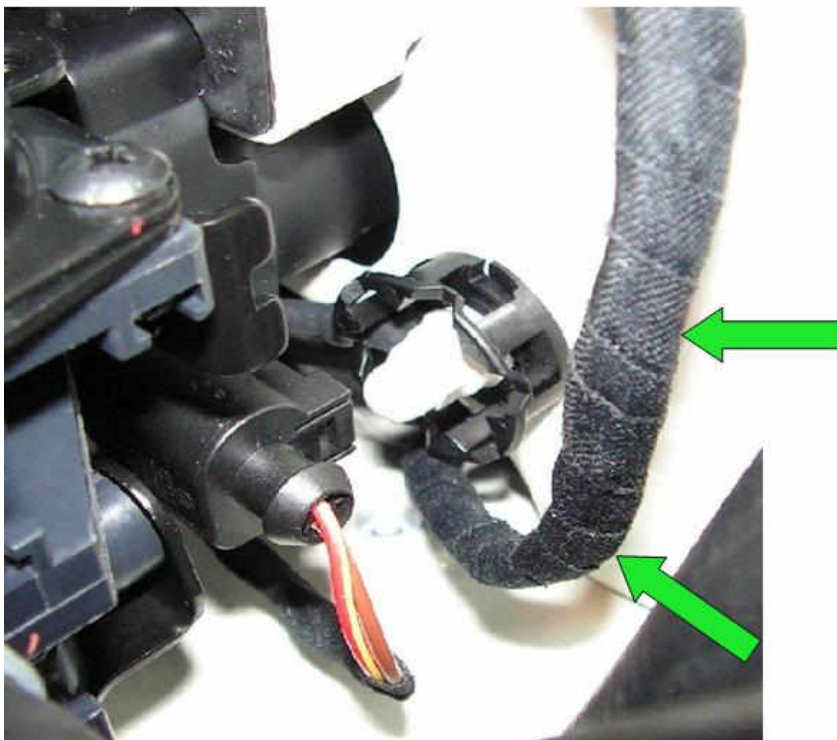
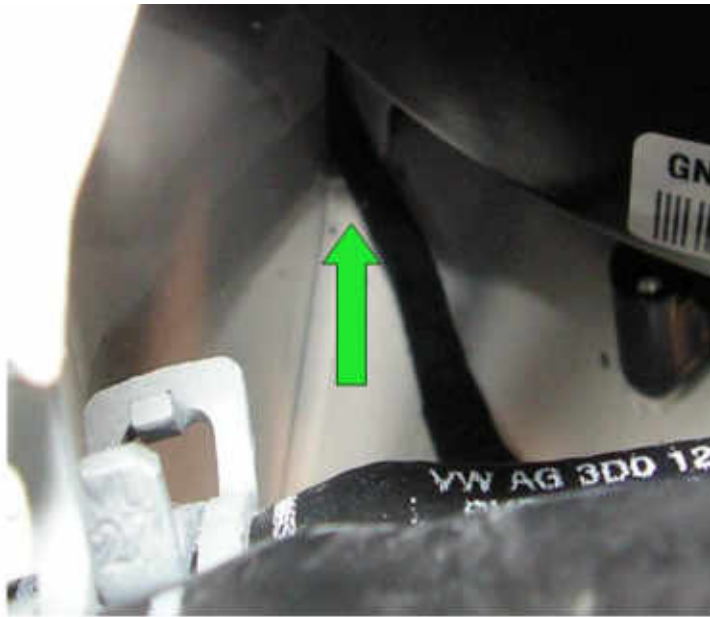
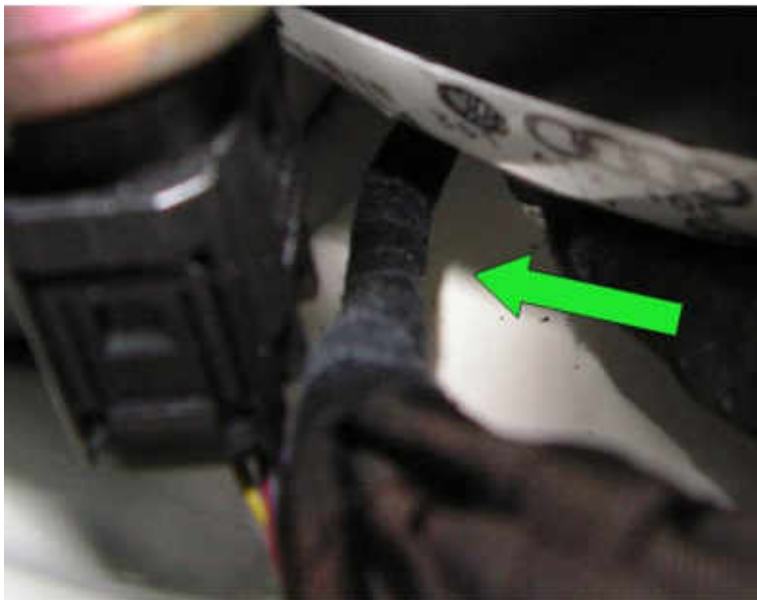
**Illustration 9:** Routing of the adapter wiring loom on the plenum chamber

**Illustration 9.1:** Routing of the adapter wiring loom on the plenum chamber

**Illustration 10:** Routing of the adapter wiring loom under brake servo

**Illustration 10.1:** Routing of the adapter wiring loom under brake servo

- Cut off the old cables on both sides; they can stay in the vehicle.
- Fit the adapter wiring loom **without** removing the air conditioning (including heat exchanger).
- The routing of the adapter wiring loom on the right plenum chamber (illustration 9, 9.1) is shown under the brake servo (10 and 10.1) and partition panels of the air conditioning.

When replacing the adapter cable make sure the routing is correct.

- The cables should not be twisted or in contact with sharp edges.
- When fitting the brown plug observe the additional locking (illustration 11).
  - It must be locked by hand (illustration 11, green arrow). But this is only possible, if the plug is completely slotted in.

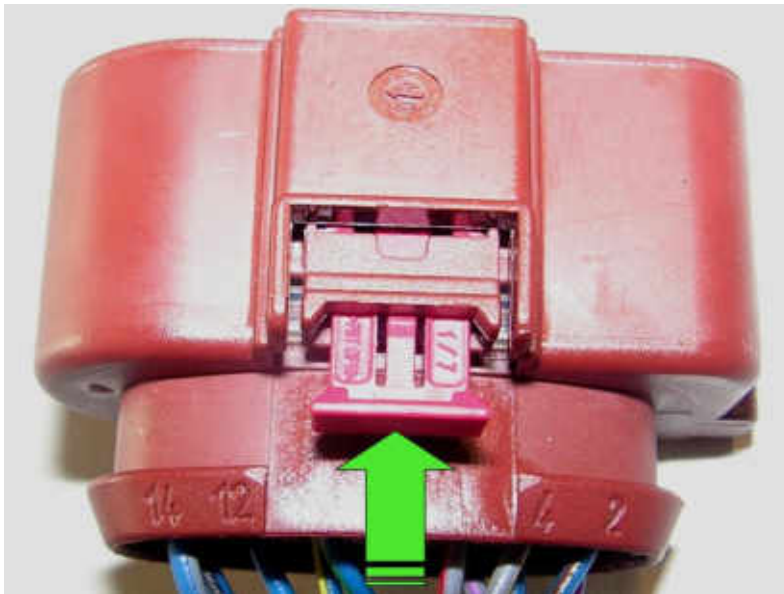
**Illustration 11:** Attachment of brown plug

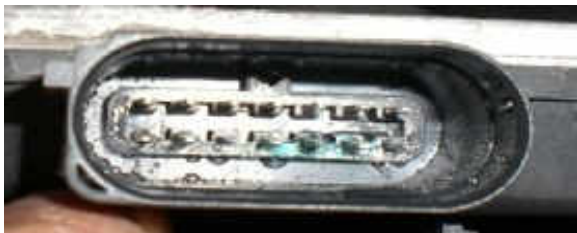
**Illustration 12:** corroded brake servo control unit contacts

The components itself may also have to be replaced because of corroded contacts on brake servo control unit and brake servo, illustration 12 and 13.

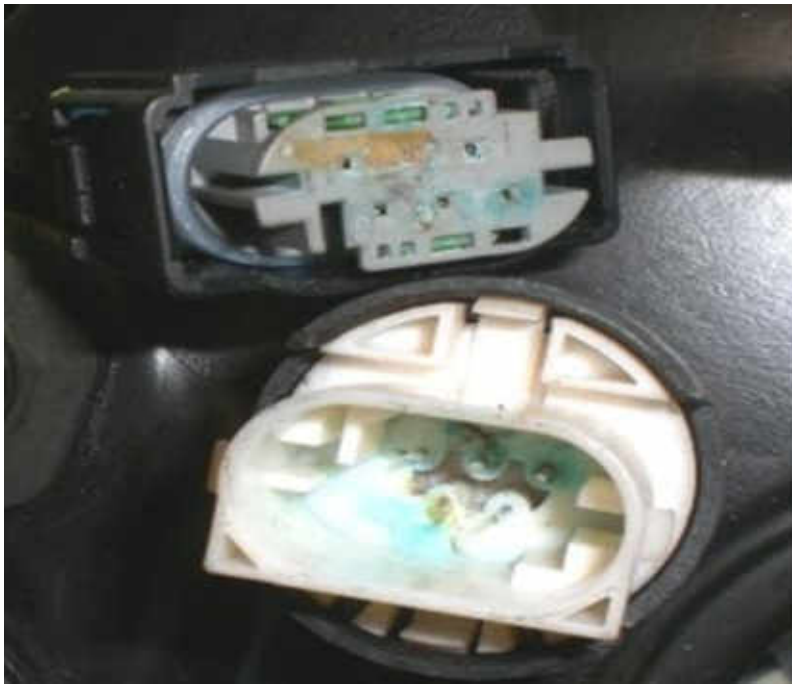
**Illustration 13:** corroded contacts on brake servo

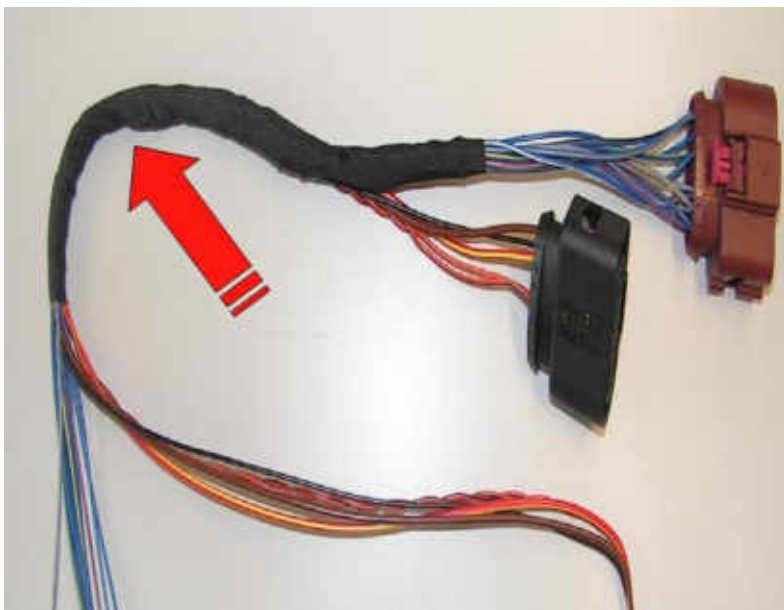
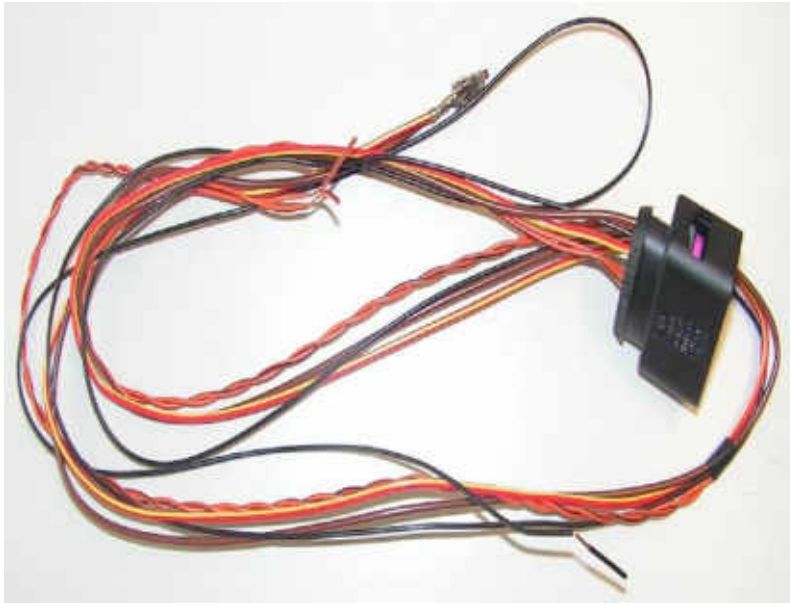
**Illustration 14:** remove the wrapping tape

**Illustration 15:** wrapping tape removed

- Remove the wrapping tape on the adapter wiring loom (illustration 14, red arrow). Illustration 15 shows the wiring loom without black wrapping tape.

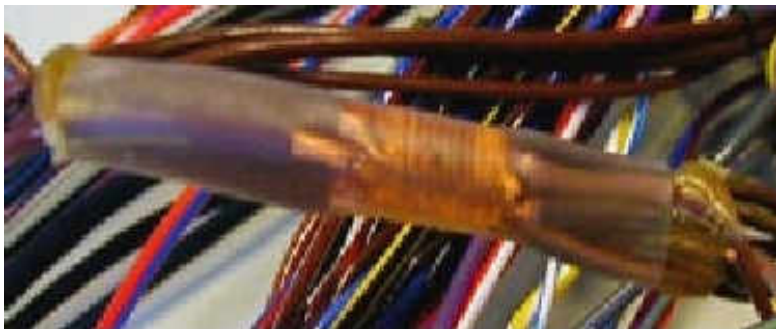
**Illustration 16:** crimp connector

- Replace only the cables with corroded contacts.
- Replace the affected cables from where the copper strand is blank.
- The necessary crimp connector must be watertight (illustration 16)

Avoid positioning the crimp connector in the dry area (E-box in plenum chamber).

The new cables would be pulled through the sealed grommet, making leaks likely.

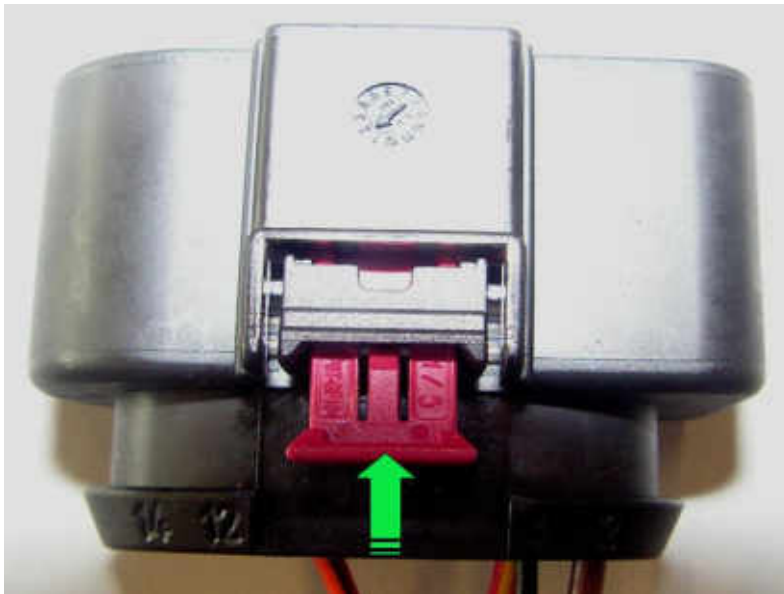
**Illustration 17:** attachment of black plug

When fitting the black plug observe the additional locking (illustration 17).

- It must be locked by hand (illustration 17, green arrow). But this is only possible, if the plug is completely slotted in.

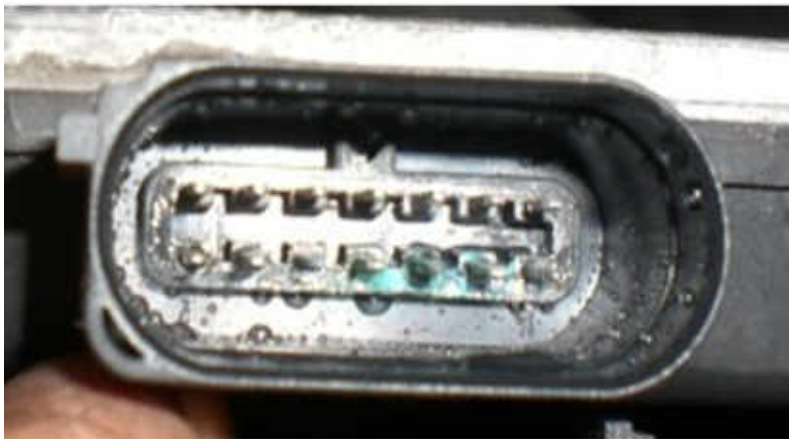
**Illustration 18:** corroded brake servo control unit contacts

Because of corroded contacts the brake servo control unit must also be replaced (illustration 18).
