Technical Bulletin

Model(s)	Year	Eng. Code	Trans. Code	VIN Range From	VIN Range To
Phaeton	2004-2006	All	All	All	All

91 11 07 March 14, 2011 2025707

Navigation System is Non-responsive and/or Reboots

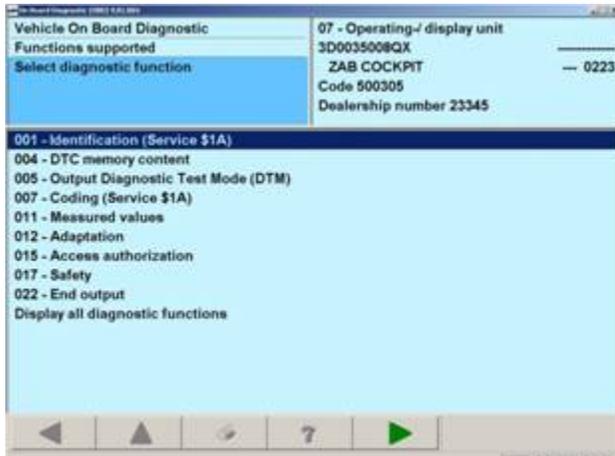
Verify Display Control Unit Software

- Select Vehicle Self - Diagnosis.
- Select on Board Diagnostics (OBD).
- Select 07 - Front Information Display Control Head.
- Verify the software is 0220 or 0223.

If the software is 188, the display control unit will need to be replaced. Control unit replacements are shipped with the 223 software.
