Technical Service Handbook

Model description: **Phaeton 4M4-sea 230_TDI6at**

Technical product information

Electrics: Adaptive Cruise Control (ACC) doesn't work, warning light on

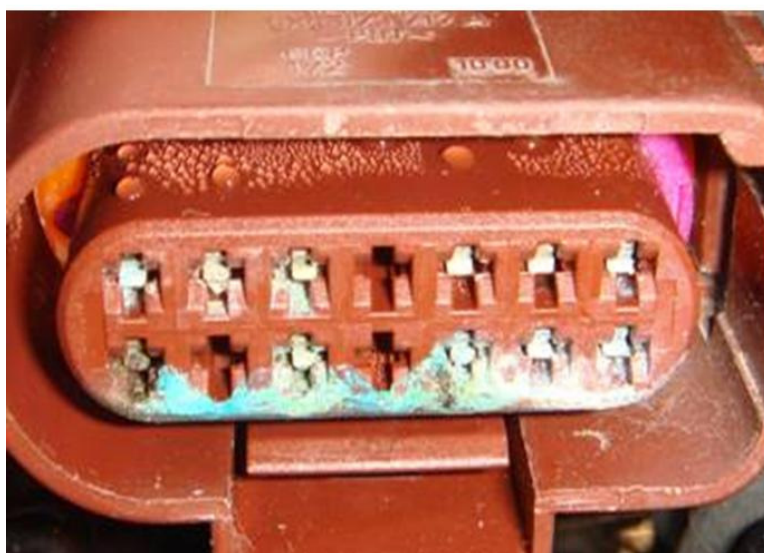
Electrics: Adaptive Cruise Control (ACC) doesn't work, warning light on

Illustration 1: Water ingress/contacts corroded on the connection (brown) of the brake servo control unit

Check the connectors on the brake servo control unit and on the brake servo for humidity and water ingress.

- Corroded cables must be replaced.
 - Fit the wiring loom **part number 3D1 970 221 N**.

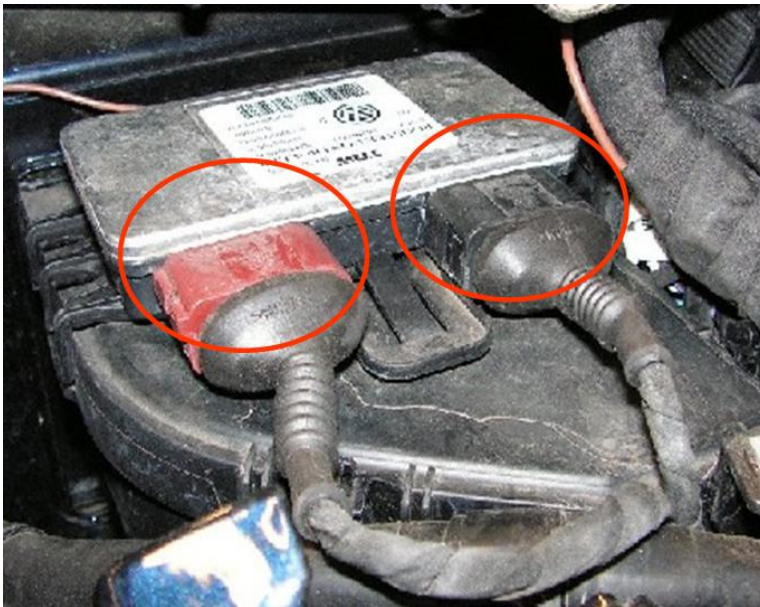
Illustration 2: Installation overview of connection on control unit

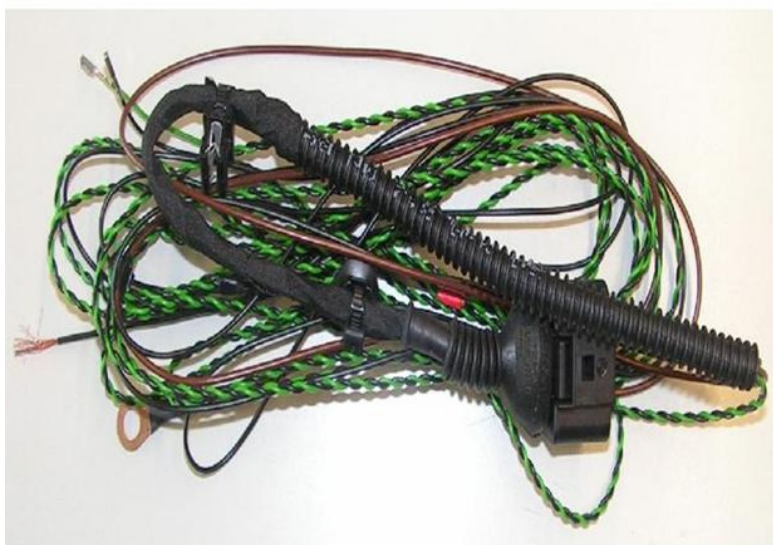
Illustration 3: Green/black cables twisted with earth connection

- Green/black cables twisted with earth connection(illustration 3). **These cables are normally not needed as replacement parts.**
- Adapter cable between brake servo control unit and brake servo (illustration 4)
- Fit also over the E-box in the plenum chamber the cover with **part number 3D0 907 299** (illustration 5).

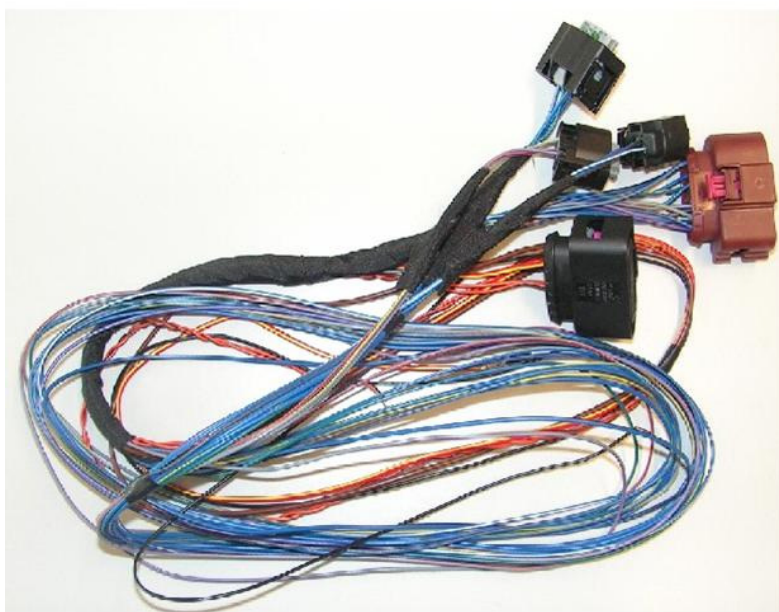
Illustration 4: Adapter wiring loom between brake servo control unit and brake servo

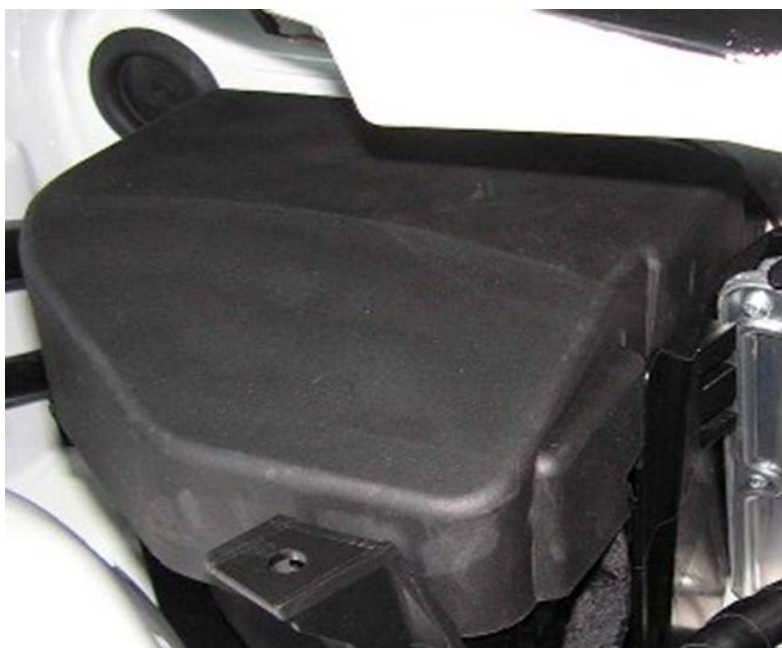
Illustration 5: cover over E-box in plenum chamber

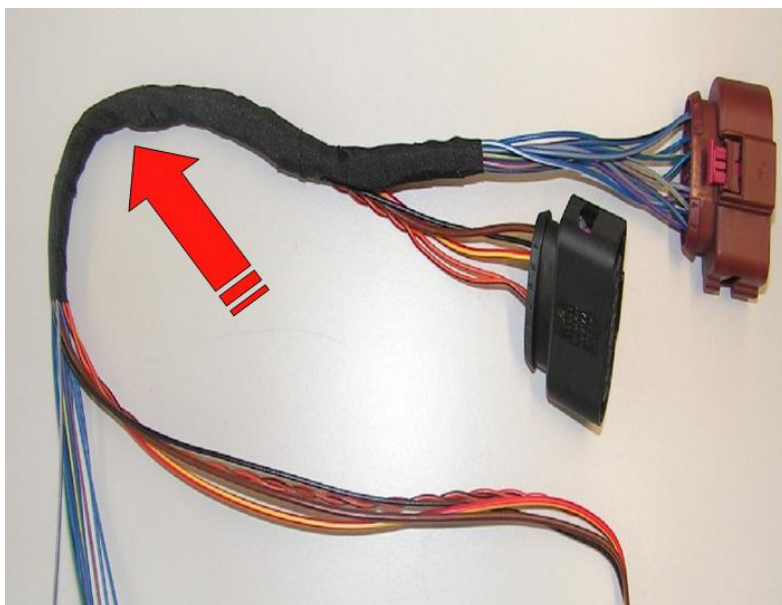
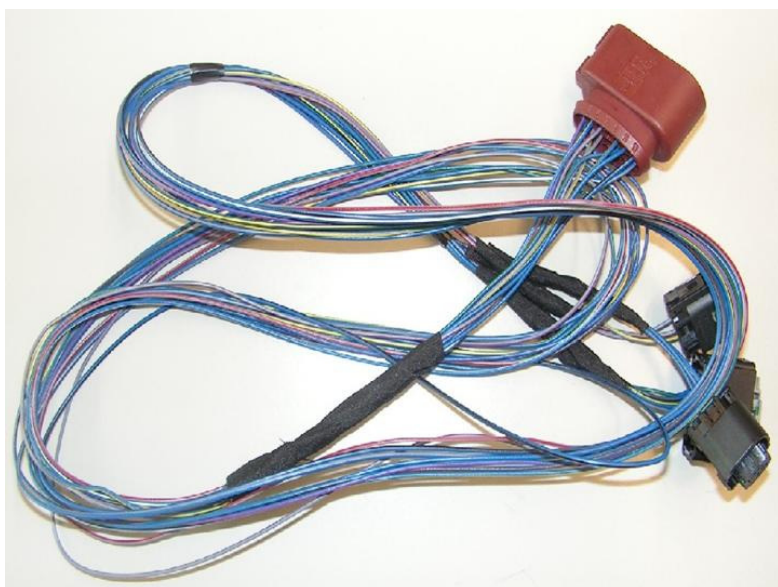
Illustration 6: Remove the wrapping tape

Illustration 7: Remove the wrapping tape

- Remove the wrapping tape on the adapter wiring loom (illustration 6, red arrow)
Illustration 7 shows the wiring loom without black wrapping tape.

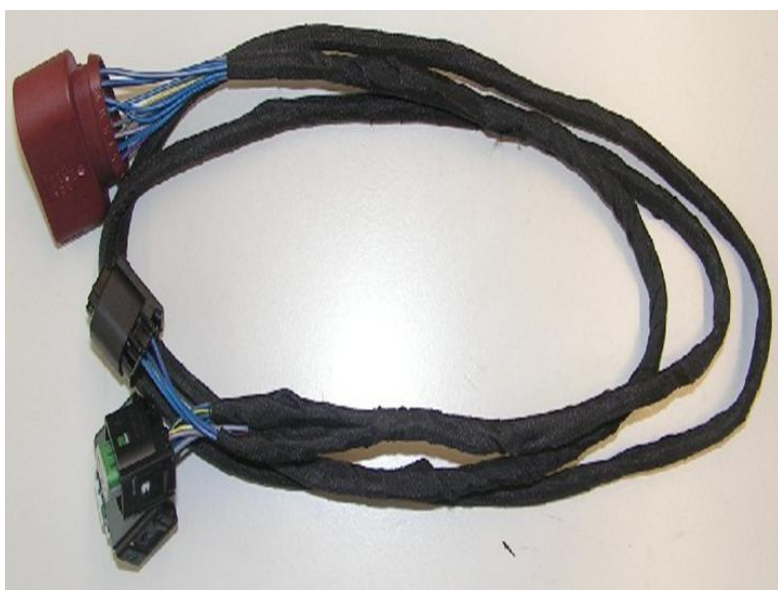
Illustration 8: Protection of adapter cable with tape

- Protect the adapter wiring loom (brown connector) and the 3 connectors to the brake servo with tape (illustration 8).

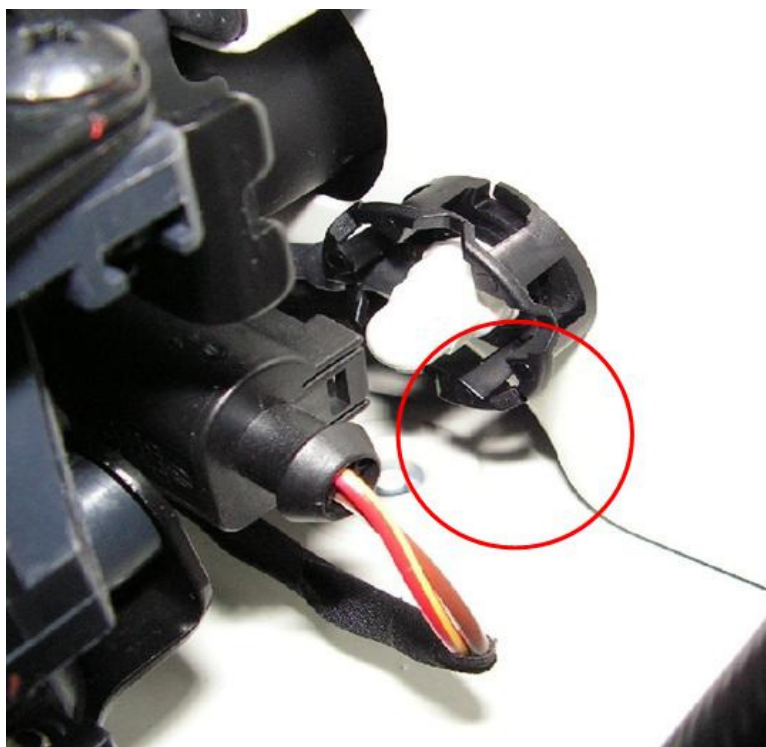
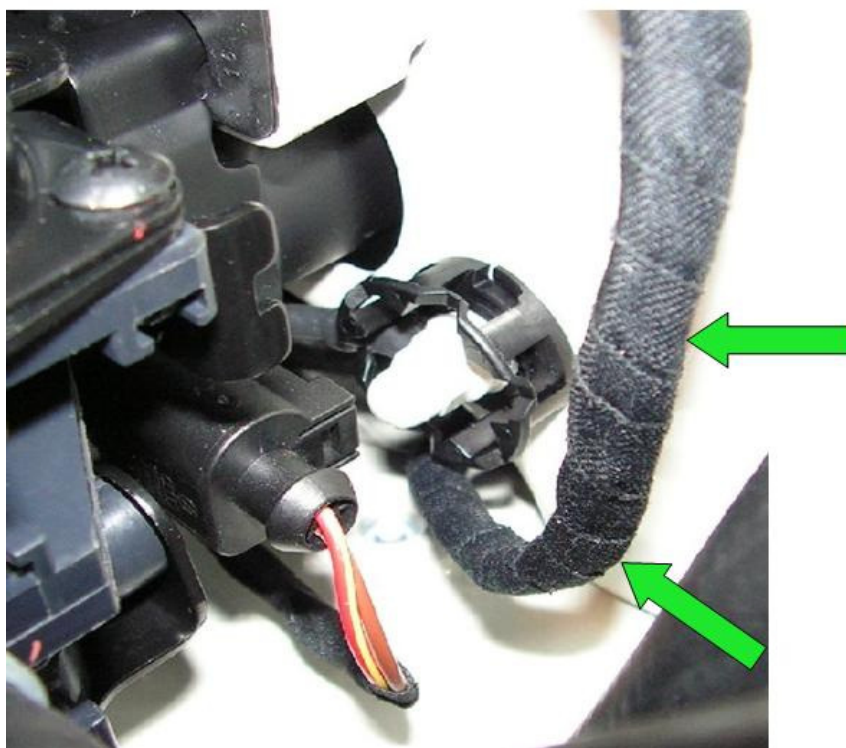
Illustration 9: Routing of the adapter wiring loom on the plenum chamber

Illustration 9.1: Routing of the adapter wiring loom on the plenum chamber

- Cut off the old cables on both sides; they can stay in the vehicle.
- Fit the adapter wiring loom **without** removing the air conditioning (including heat exchanger).
- The routing of the adapter wiring loom on the right plenum chamber (illustration 9, 9.1) is shown under the brake servo (10 and 10.1) and partition panels of the air conditioning.

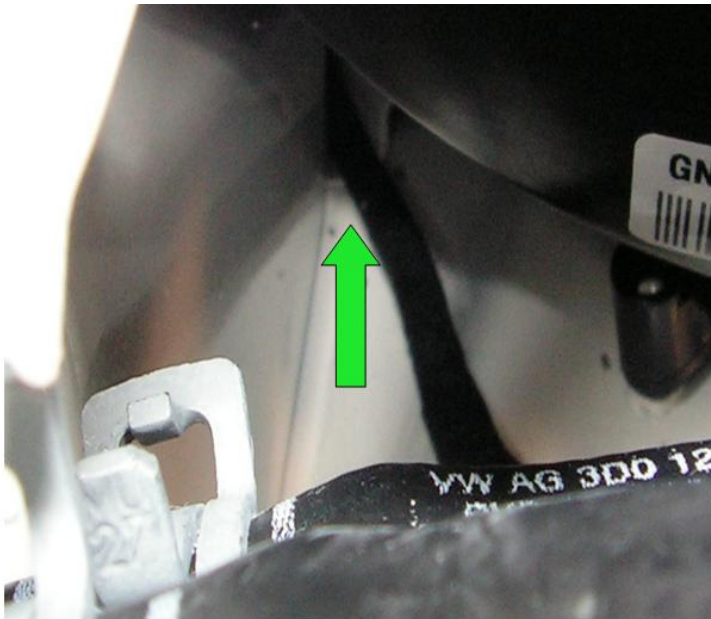
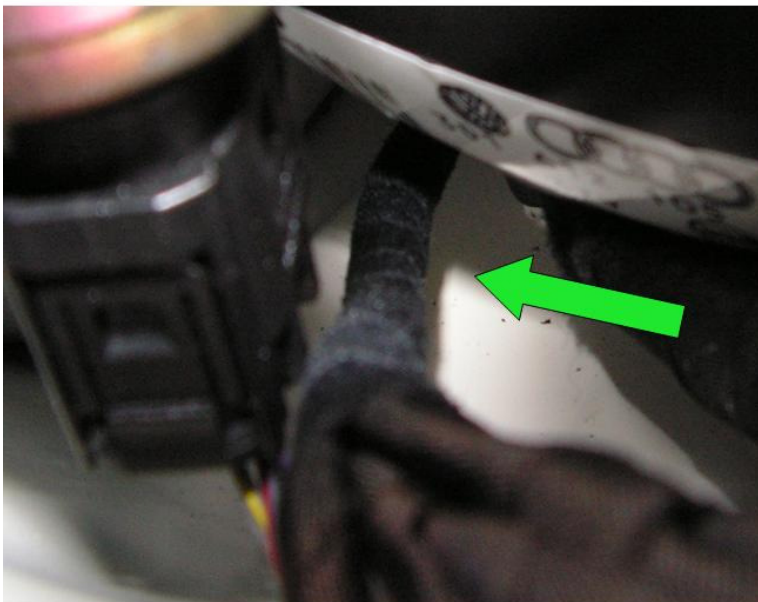
Illustration 10: Routing of the adapter wiring loom under brake servo

Illustration 10.1: Routing of the adapter wiring loom under brake servo

When replacing the adapter cable make sure the routing is correct.

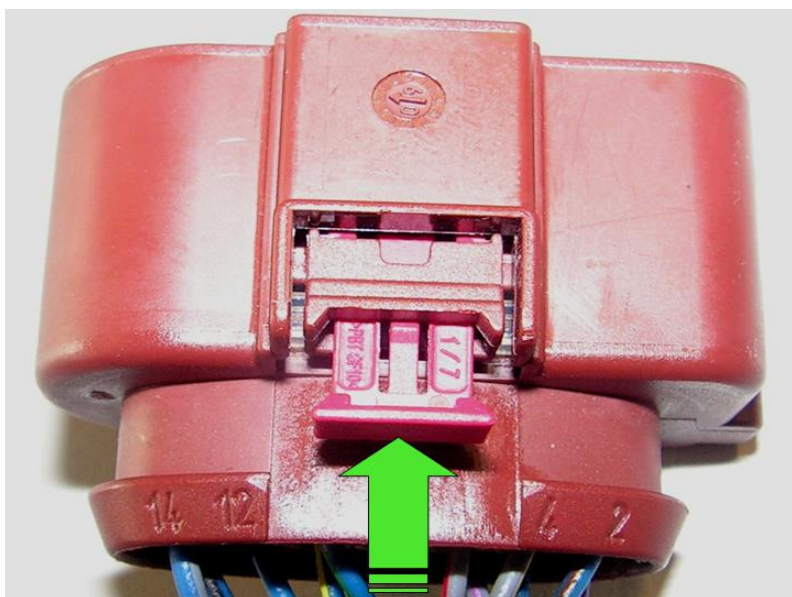
Illustration 11: Attachment of brown plug

- The cables should not be twisted or in contact with sharp edges.
- When fitting the brown plug observe the additional locking (illustration 11).
 - It must be locked by hand (illustration 11, green arrow). But this is only possible, if the plug is completely slotted in.

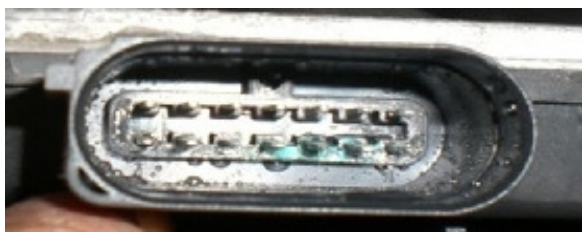
A) Only the contacts in the brown plug on the brake servo control unit are corroded.

Illustration 12: corroded brake servo control unit contacts

The components itself may also have to be replaced because of corroded contacts on brake servo control unit and brake servo, illustration 12 and 13.

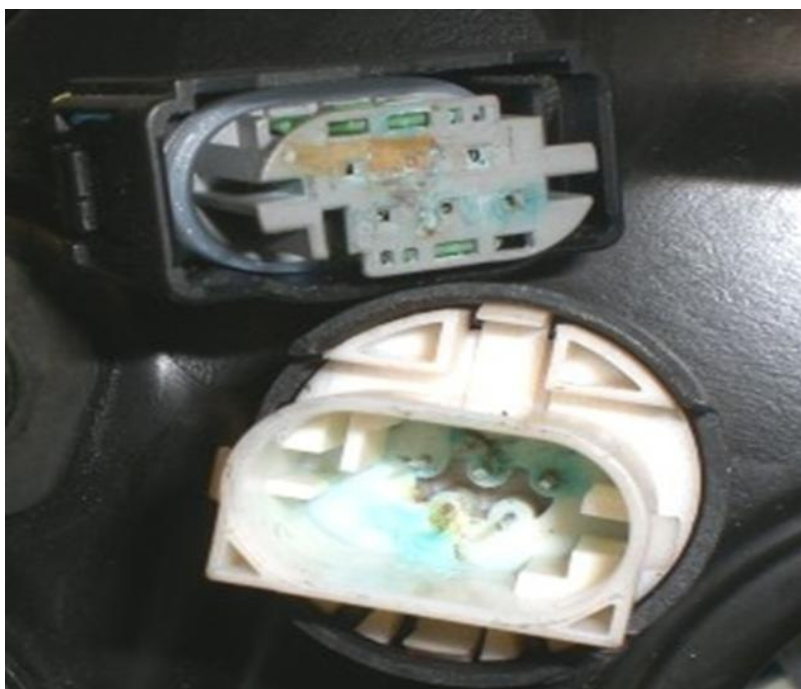
Illustration 13: corroded contacts on brake servo

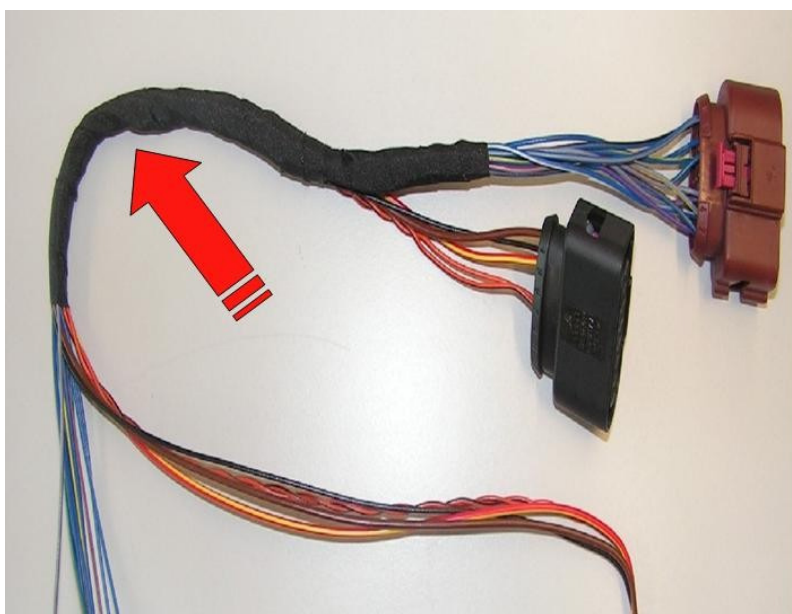
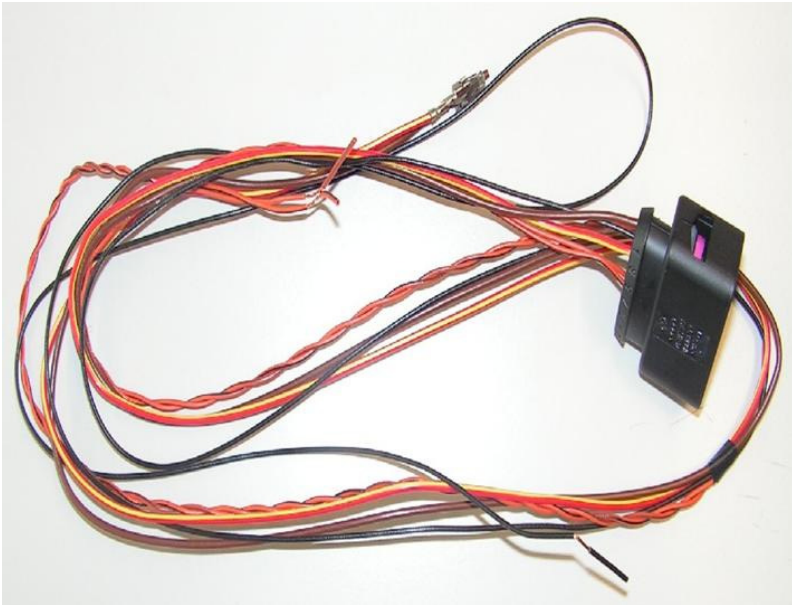
B) Only the contacts in the black plug on the brake servo control unit are corroded:

Illustration 14: remove the wrapping tape

Illustration 15: wrapping tape removed

- Remove the wrapping tape on the adapter wiring loom (illustration 14, red arrow). Illustration 15 shows the wiring loom without black wrapping tape.

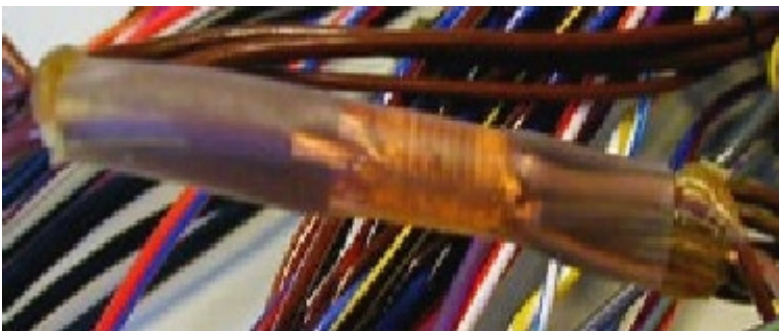
Illustration 16: crimp connector

- Replace only the cables with corroded contacts.
- Replace the affected cables from where the copper strand is blank.
- The necessary crimp connector must be watertight (illustration 16)

Avoid positioning the crimp connector in the dry area (E-box in plenum chamber).
The new cables would be pulled through the sealed grommet, making leaks likely.

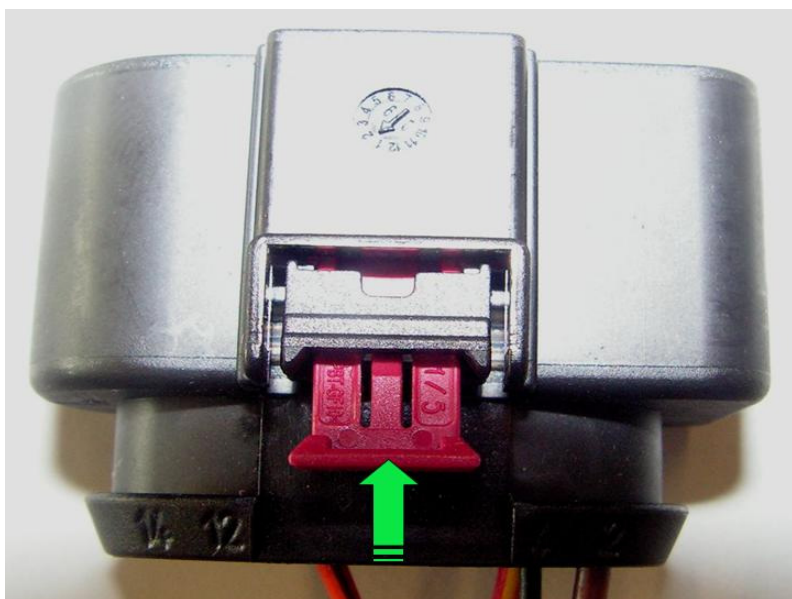
Illustration 17: attachment of black plug

When fitting the black plug observe the additional locking (illustration 17).

- It must be locked by hand (illustration 17, green arrow). But this is only possible, if the plug is completely slotted in.

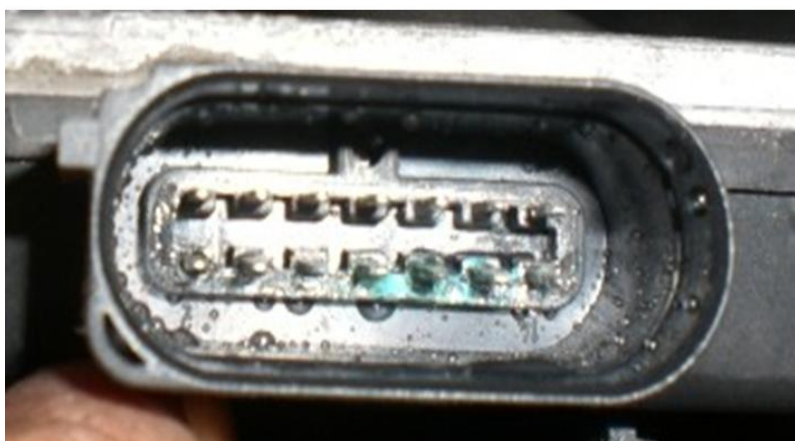
Illustration 18: corroded brake servo control unit contacts

Because of corroded contacts the brake servo control unit must also be replaced (illustration 18).
