## Technical Service Handbook

Model description: **Phaeton 4M4-sea 230\_TDI6at**

### Technical product information

Electrics: Adaptive Cruise Control (ACC) doesn't work, warning light on

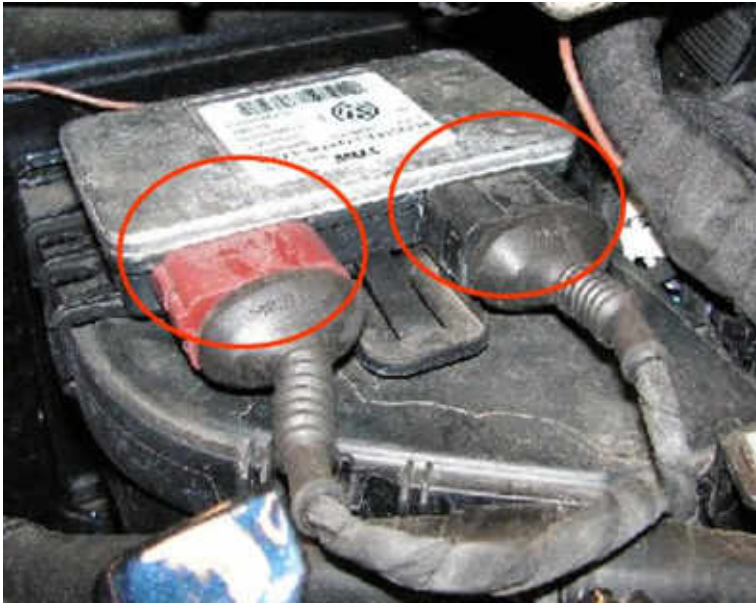
**Illustration 2:** Installation overview of connection on control unit

Check the connectors on the brake servo control unit and on the brake servo for humidity and water ingress.

- Corroded cables must be replaced.
  - Fit the wiring loom **part number 3D1 970 221 N**.
